Source Control (Phase 1) Remedy

#### Standard Mine Site

- Historic mining area lead, zinc, copper, silver
- EPA-lead site with U.S. Forest Service and State of Colorado
- Located at 11,000 feet; 3 month construction season; Limited winter access
- Listed on NPL August 2005; ROD signed September 2011
- One OU Two phased remedy, if needed

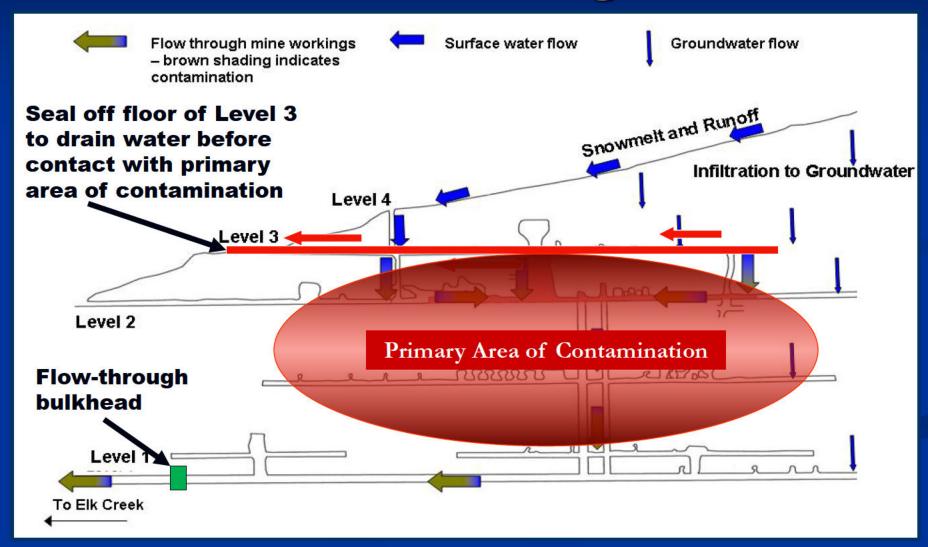
### Proposed Cleanup Strategies Inside Mine Workings

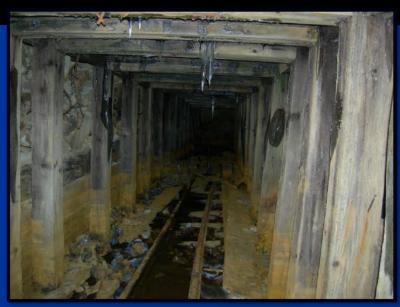
Level 1 adit portal

# Bulkhead in Level 1 to reduce blowout potential and control water releases

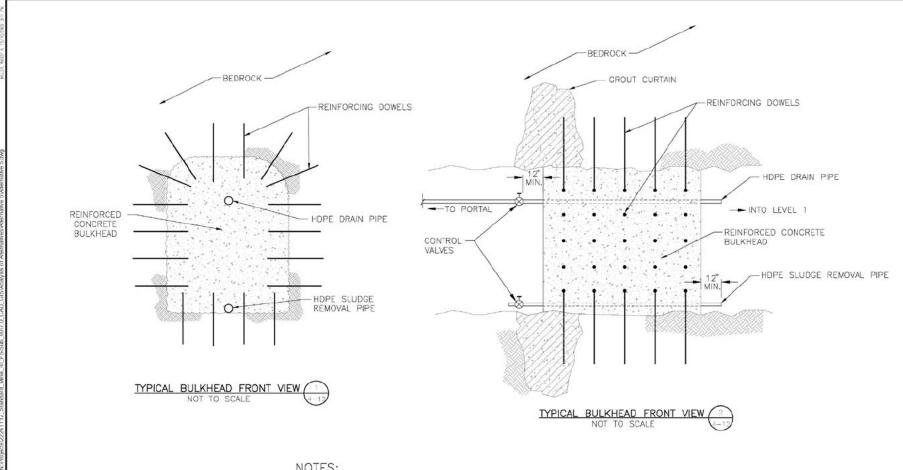
STANDARD MINE GUNNISON COUNTY, CO Alternative 5 Bulkhead in Level 1 Figure 4-12

#### Bulkhead at Level 1

- 1. BULKHEAD CONSTRUCTED WITH A MINIMUM OF 150 FEET OF BEDROCK COVER.
- 2. HDPE DRAIN PIPE EXTENDS OLTSIDE OF THE PORTAL (NOT SHOWN). A CONTROL VALVE TO BE INSTALLED INSIDE OF THE PORTAL FOR RELEASE OF RETAINED DRAINAGE.

#### **Bulkhead in Level 1**

- Rehabilitate adit to allow construction
- Concrete flow-through bulkhead
  - Valve to regulate discharge
- Pipes for discharge and cleanout
- Controlled water discharge from Level 1
- Used to control flow to Phase 2 water treatment system, if needed

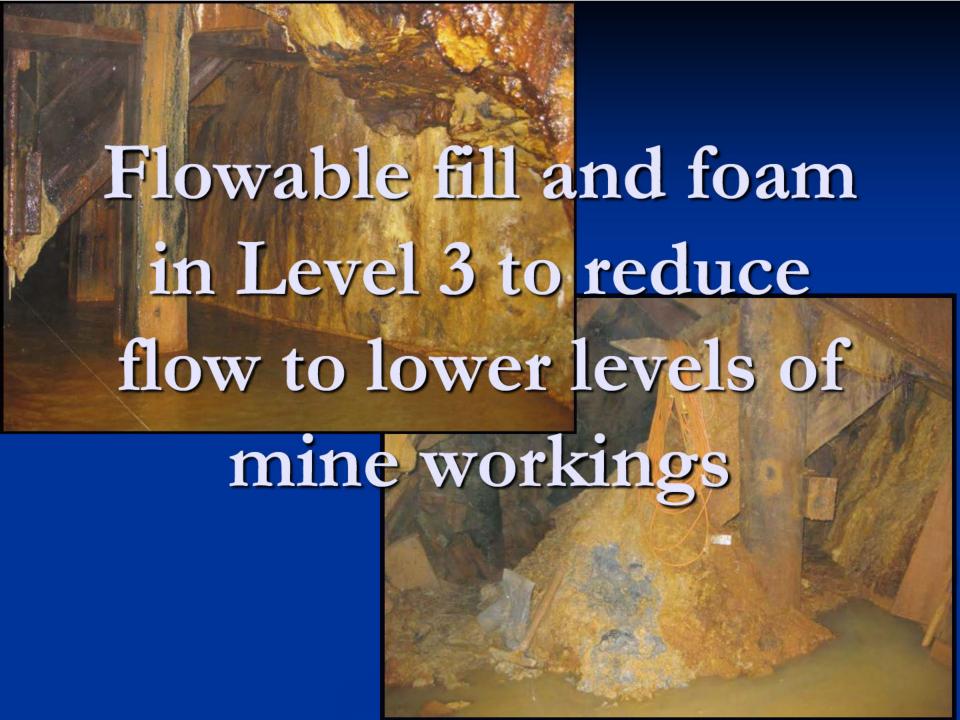
#### Flowable Fill and Foam – Level 3

- Rehabilitate Level 3 adit
- Seal raises to lower mine workings with foam
- Fill fractures and mineralized zones on ribs and floor
- Seal floor with flowable fill
- Level 3 water directed to exit at portal
- Convey discharge to Elk Creek at Level 1

- REMOVE ROCK AT HEAD OF RAISE UNTIL TIMBER CAN BE SET ON COMPETENT ROCK.
- 2. SET TIMBER COLLAR FLUSH WITH FLOOR.
- LEAVE 6-INCH MINIMUM GAP BETWEEN TOP OF FOAM AND TOP OF TIMBER COLLAR.
- 4. BOTTOM FORM TO BE PLYWOOD OR OTHER SUITABLE MATERIAL STRONG ENOUGH TO SUPPORT WEIGHT OF FOAM.
- 5. GAPS BETWEEN BOTTOM FORM AND RAISE WALLS TO BE PLUGGED WITH PLASTIC TARP, CARPET, SMALL FOAM BLOCKS, ETC. TO MINIMIZE LEAKAGE OF FOAM BETWEEN GAPS BEFORE FOAM SETS.
- FLOOR TO BE CLEARED OF DEBRIS, PIPE, RAIL, LOOSE TIMBER, ETC. BEFORE PLACING FLOWABLE FILL.
- FLOWABLE FILL TO BE PLACED WITH MIN, DEPTH OF 12 INCHES FROM FACE TO PORTAL MAINTAINING POSITIVE DRAINAGE AND INCORPORATING A REVERSE CROWN TO FACILITATE DRAINAGE.
